1987
**PARK EVALUATION
&
SITE SUMMARIES**

EVALUATION OF
CITY OF BOSTON
PARK AND RECREATION LAND

NEIGHBORHOOD OF MATTAPAN

THE HALVORSON COMPANY, INC.
LANDSCAPE ARCHITECTS AND
SITE PLANNING CONSULTANTS
161 MASSACHUSETTS AVENUE
BOSTON, MASSACHUSETTS 02115

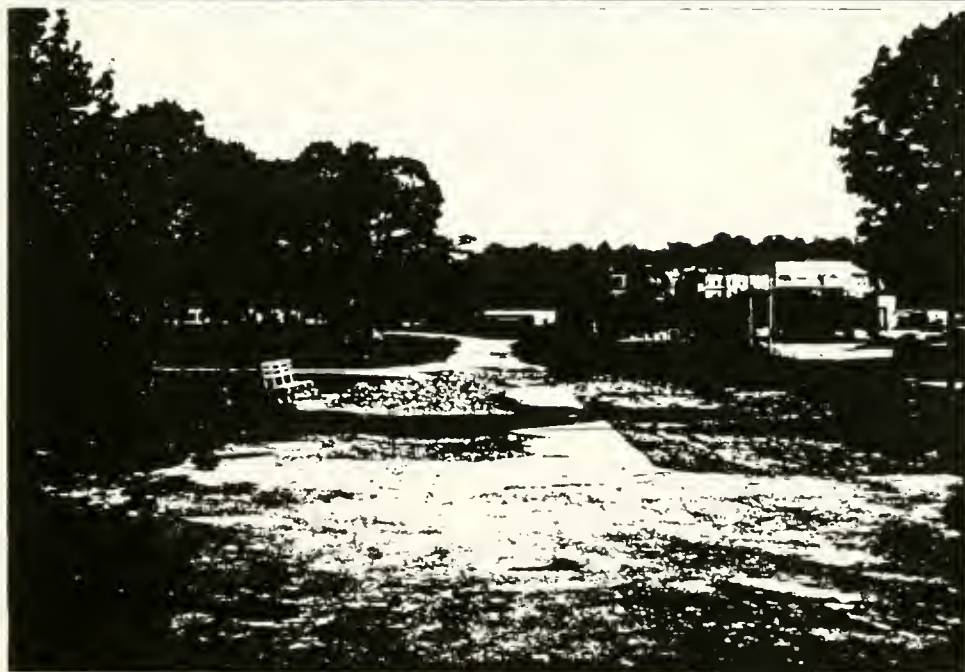
**Site Photograph 3**

Area of pavement
in poor condition,
worn grass.

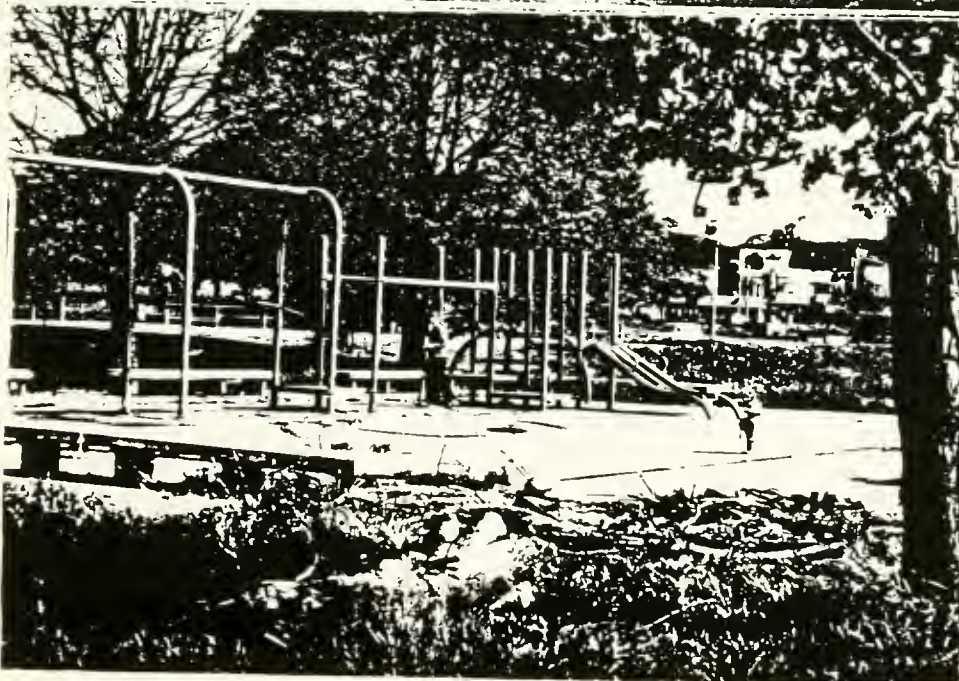
Site Photograph 18

Playground - Debris from dead tree needs removal. Rubber safety surface at base of structure easily removed. No slats left on swings.

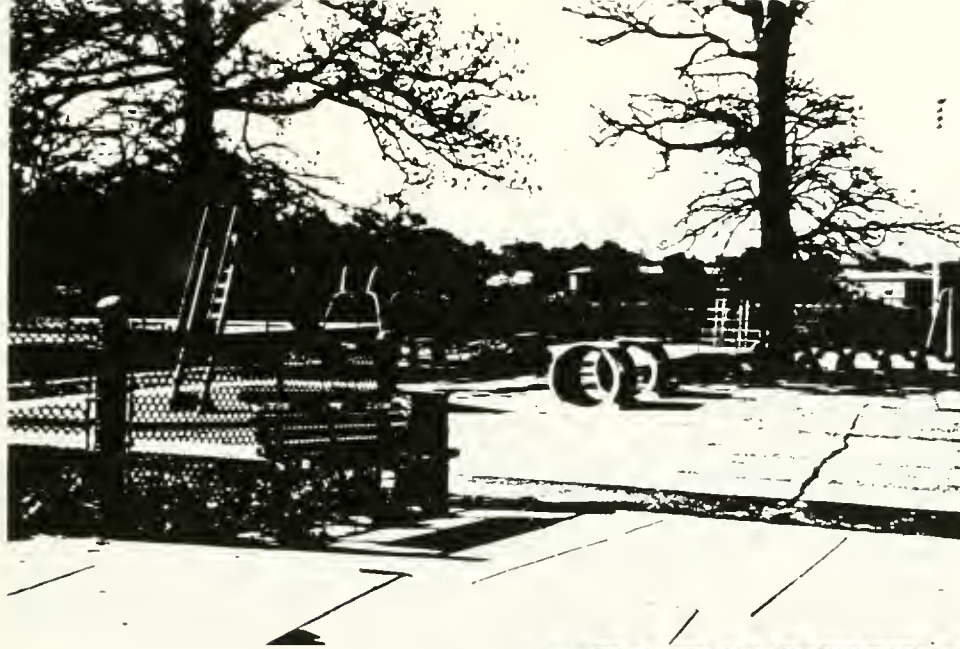
Site Photograph 13

Playground. Mature trees have been encased in pavement.

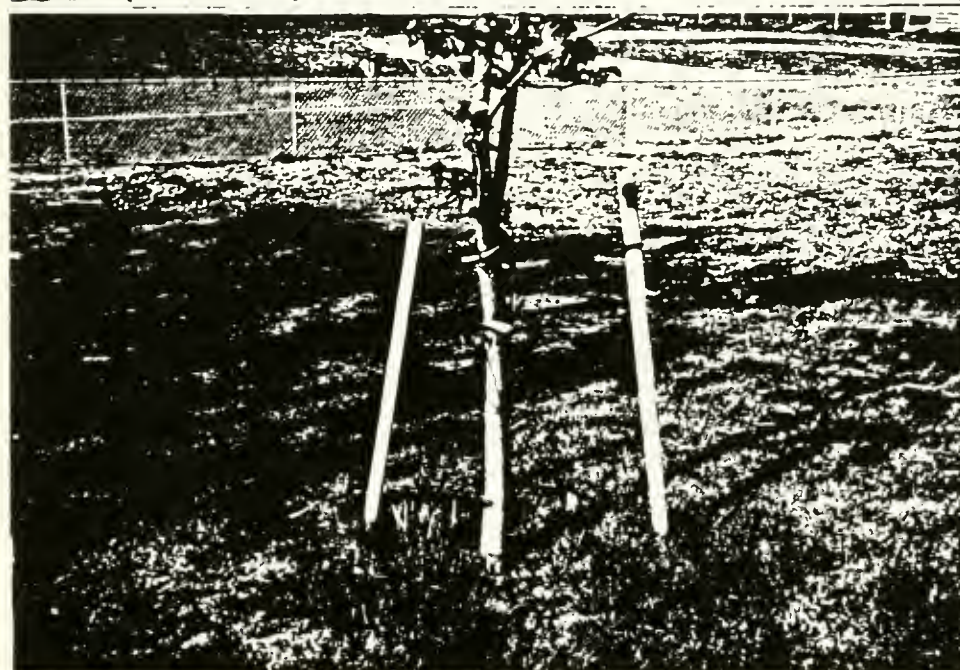
Site Photograph 15

Recent tree plantings. Guy wires and poles should be removed.

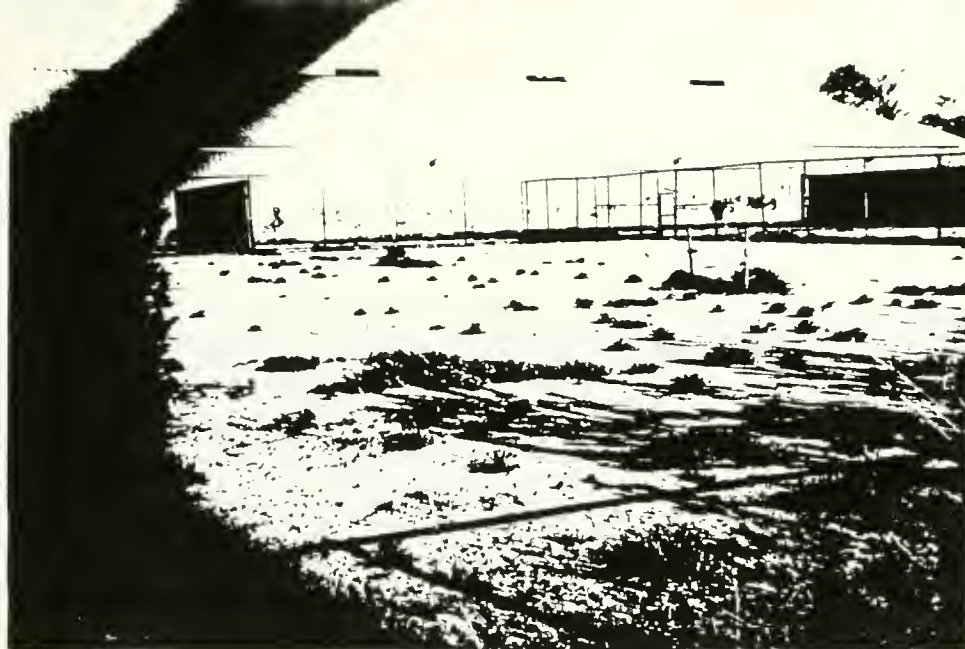
Site Photograph 7

Clay surface tennis courts - unusable.

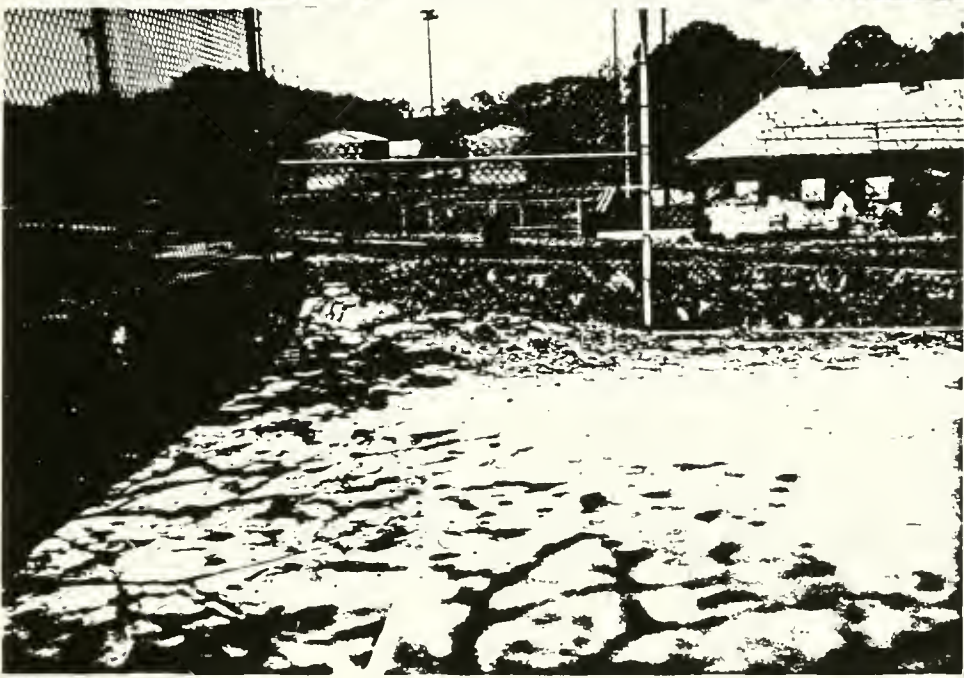
Site Photograph 2

Trash build-up in corner of basketball courts. Fence installed at base of wall results in leaves and debris trapped between them.

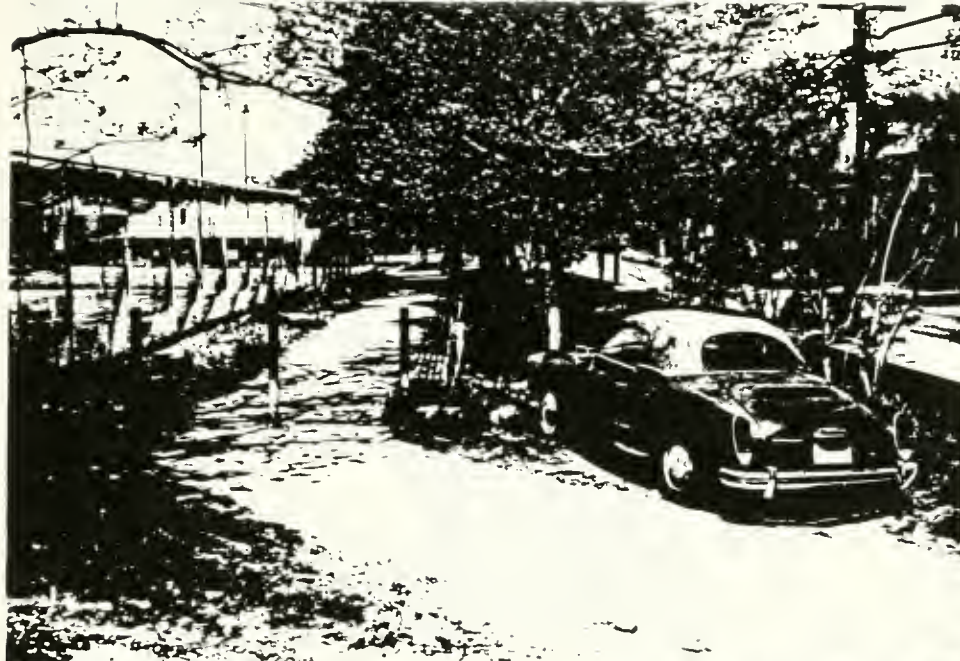
Site Photograph 4

Walkway along edge of park. Well-built wall but blocks visibility into park. Trees growing well in generous plant bed. Car inappropriately parked.

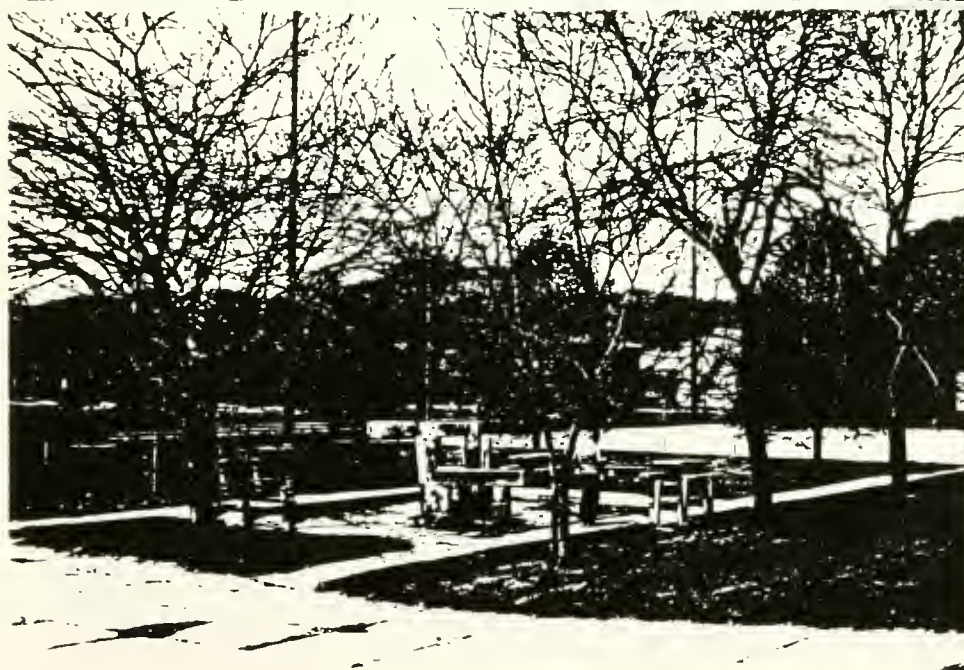
Site Photograph 6

Timber play structure - in poor condition. Shade trees good.

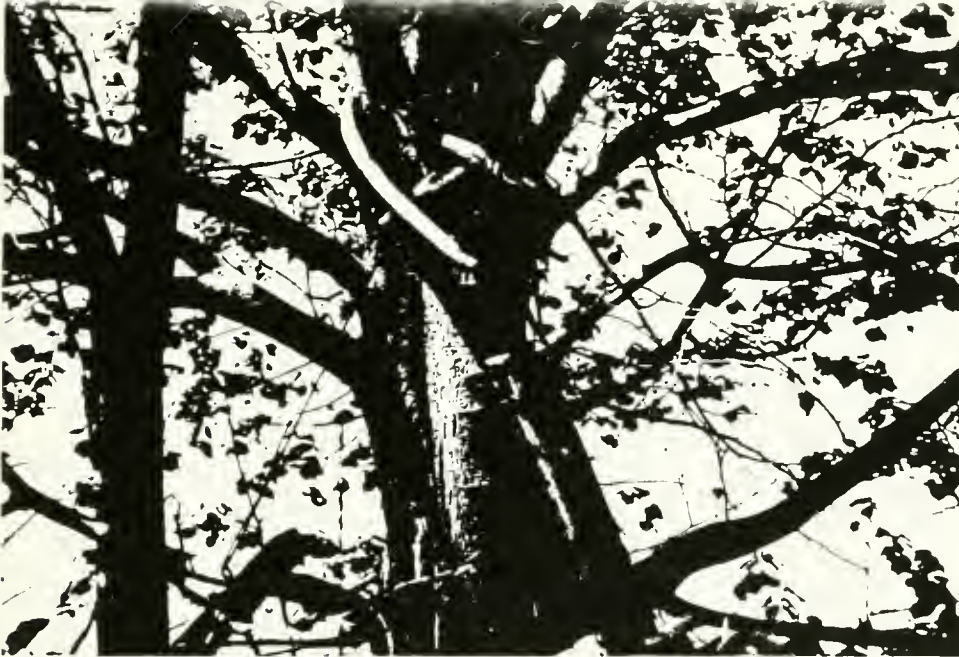
Site Photograph 7

Guy wires and stakes
have been on trees
8 years and should
be removed immediately.

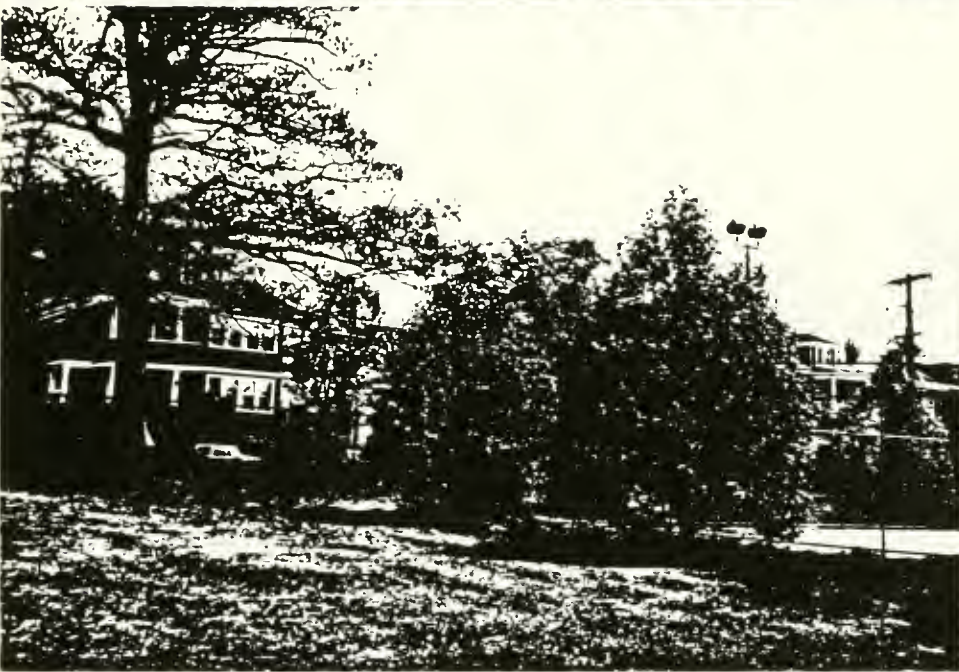
Site Photograph 8

Poor grass mowing -
small mower not used
to get into corners.

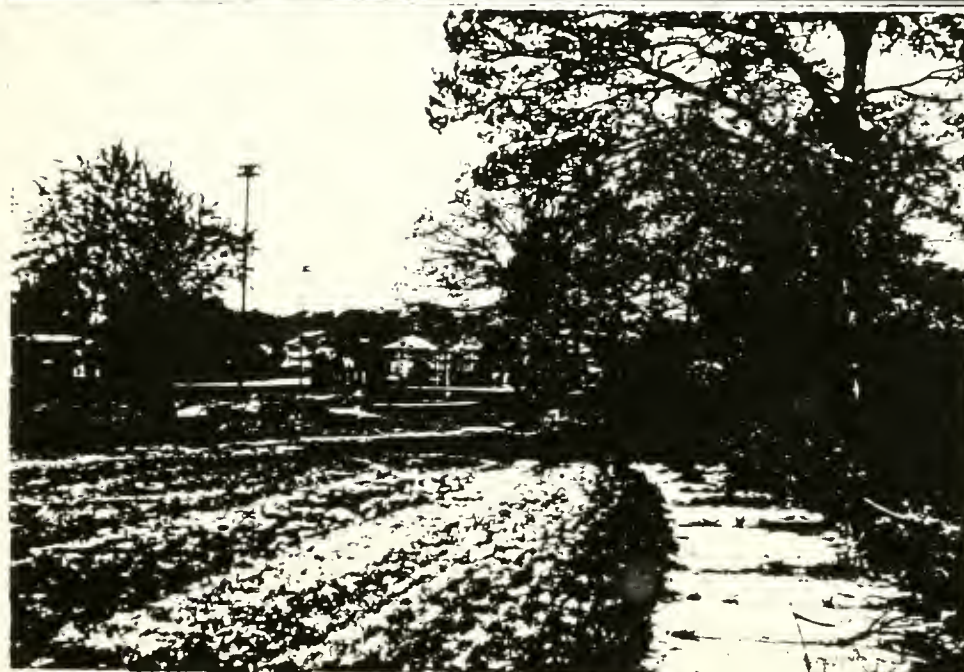
Site Photograph 12

Well laid-out walkway - in need of weeding.

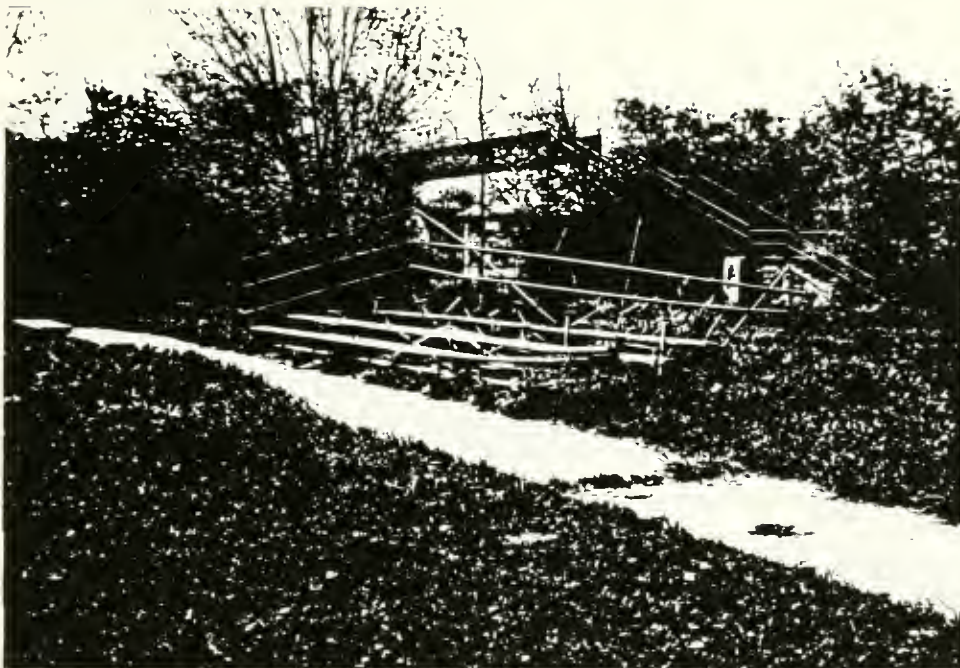
**Site Photograph 1**

Bleachers - unusable
due to vandalism.
Pedestrian railroad
bridge should be
attended to -
a safety hazard due to
deterioration.

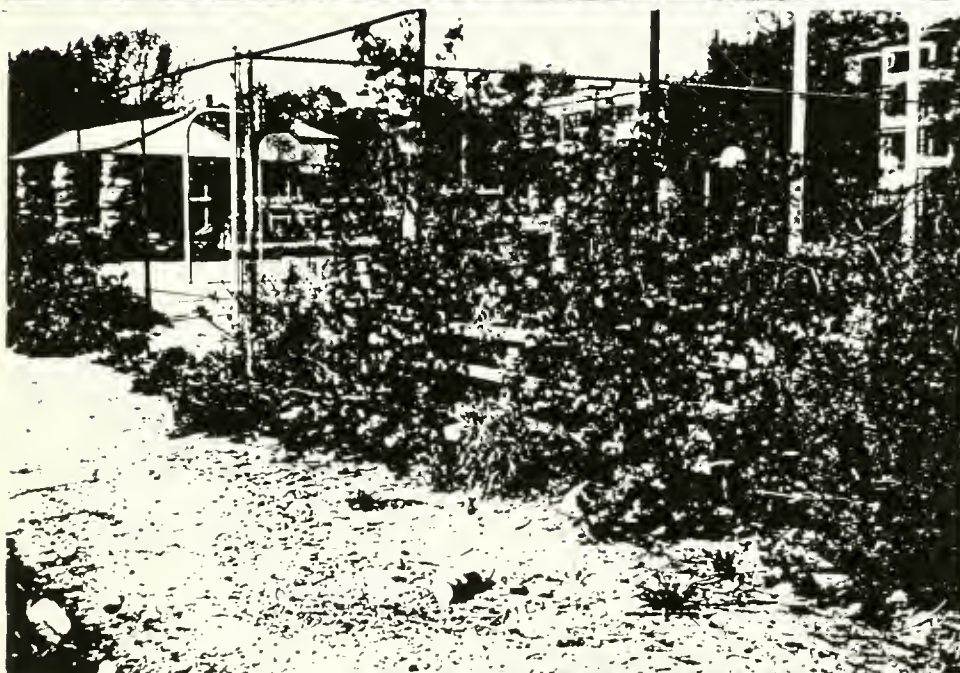
**Site Photograph 2**

Weed tree growth along
fenceline has
demolished bench.
Sidewalk surface poor.

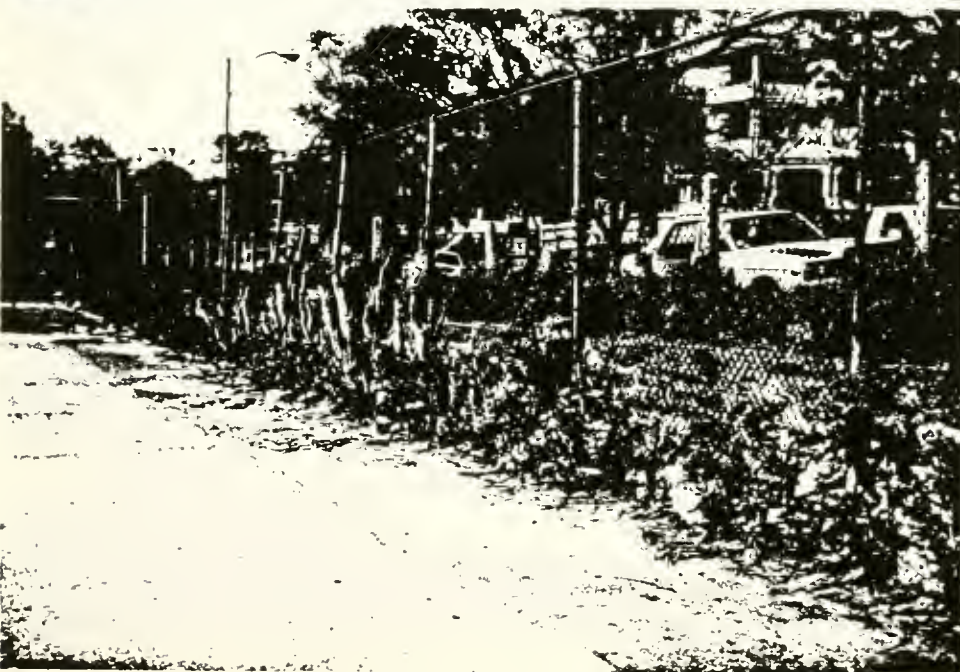
**Site Photograph 3**

Location of fence at
base of retaining
wall creates a
condition that is
very difficult to keep
weed free.

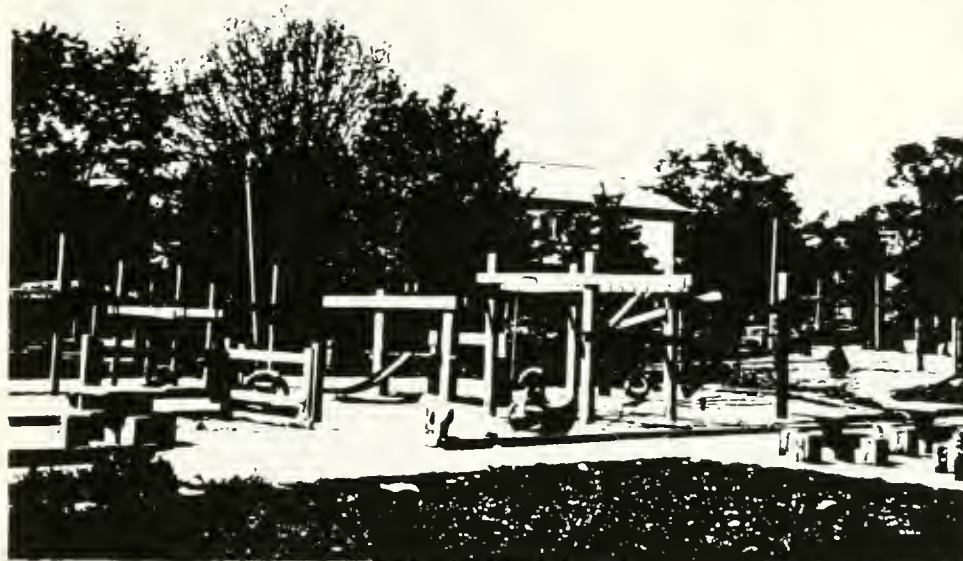
Site Photograph 10

Playground - Concrete play animals and timber climbing structures. Note fence down at corner at right, and grass worn by foot traffic.

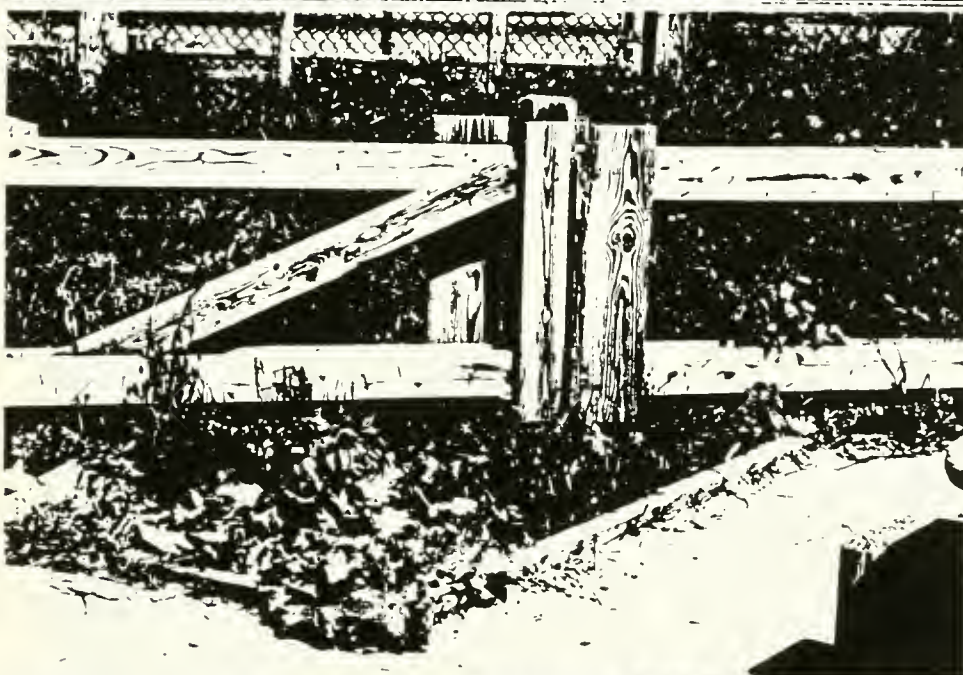
Site Photograph 11

Wood fence - picket removed and nail points protruding.

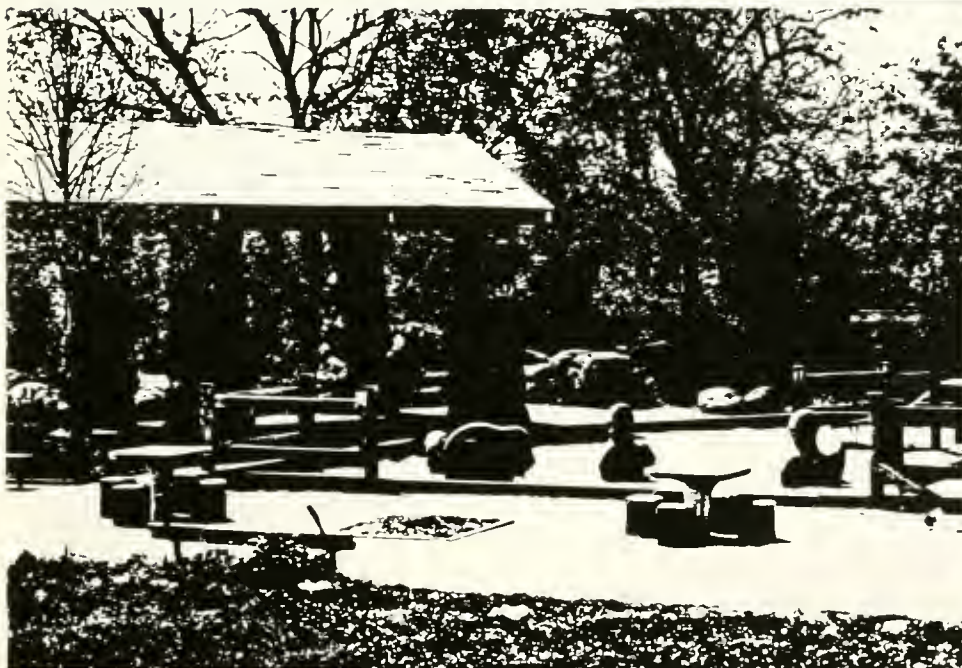
Site Photograph 12

Playground - note broken concrete animals, benches and graffiti. Park shelter and ruins of old house behind.

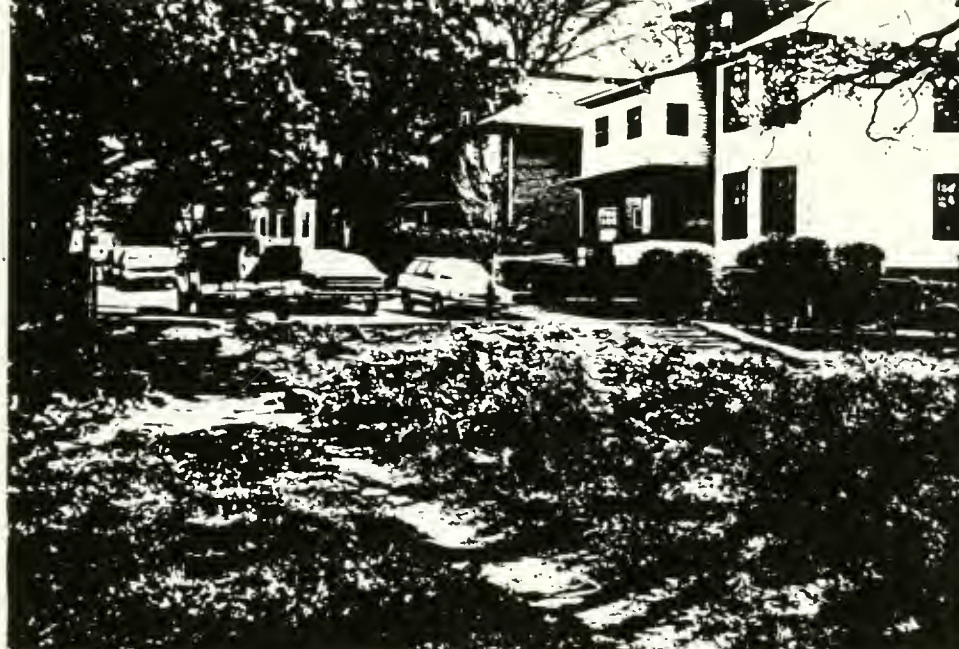
Site Photograph 7

Access from end street well used, but stairways badly deteriorated

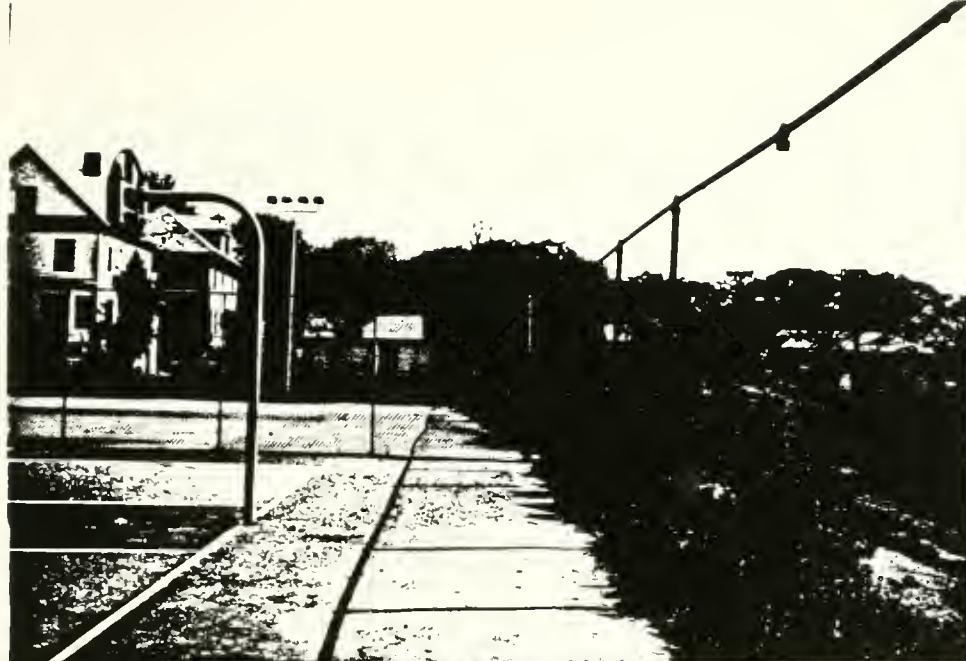
Site Photograph 4

Fencing removed. Weed growth along edge unsightly.

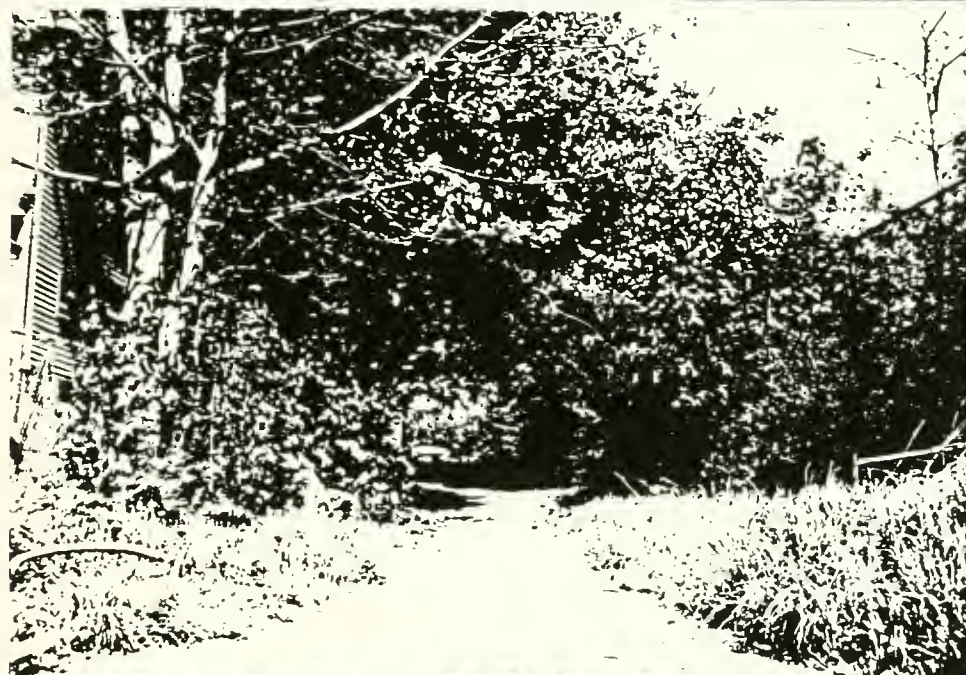
Site Photograph 5

Unkempt access from Norfolk Street. Overgrown planting gives walkway a feeling of lack of safety. Abandoned tennis court at right.

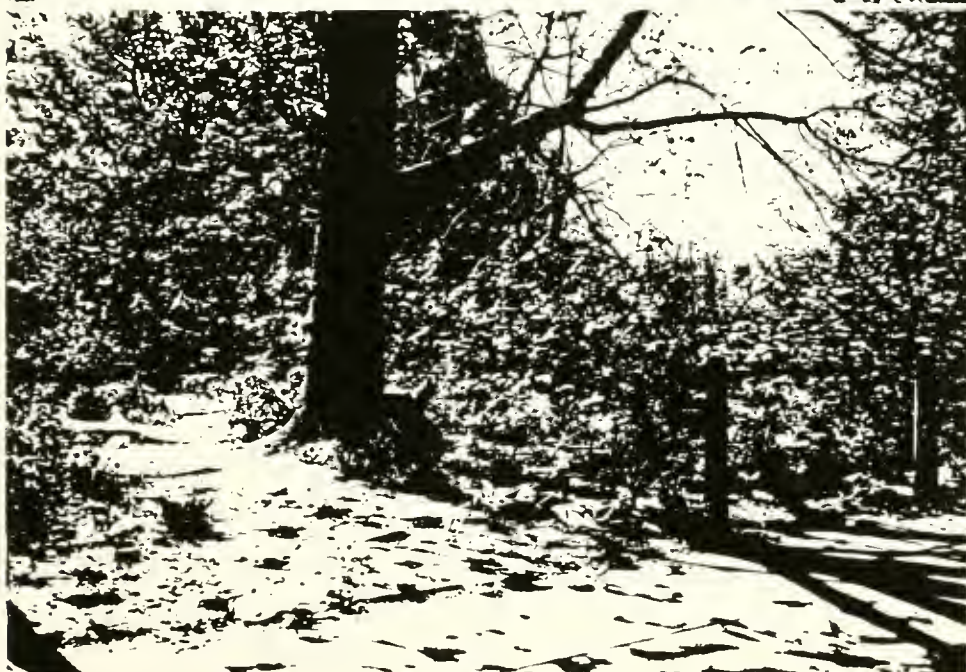
Site Photograph 6

Entrance to park from Norfolk Street area unmaintained. Dumping of trash and building materials.

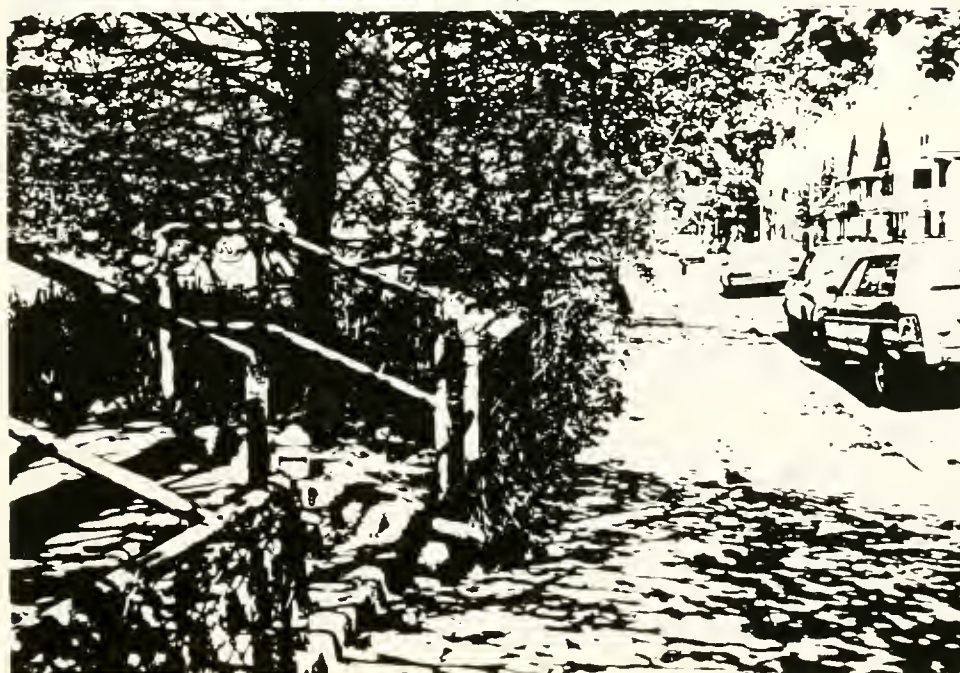
Site Photograph 3

Trash build-up and weed growth along fence line on Thetford Avenue.

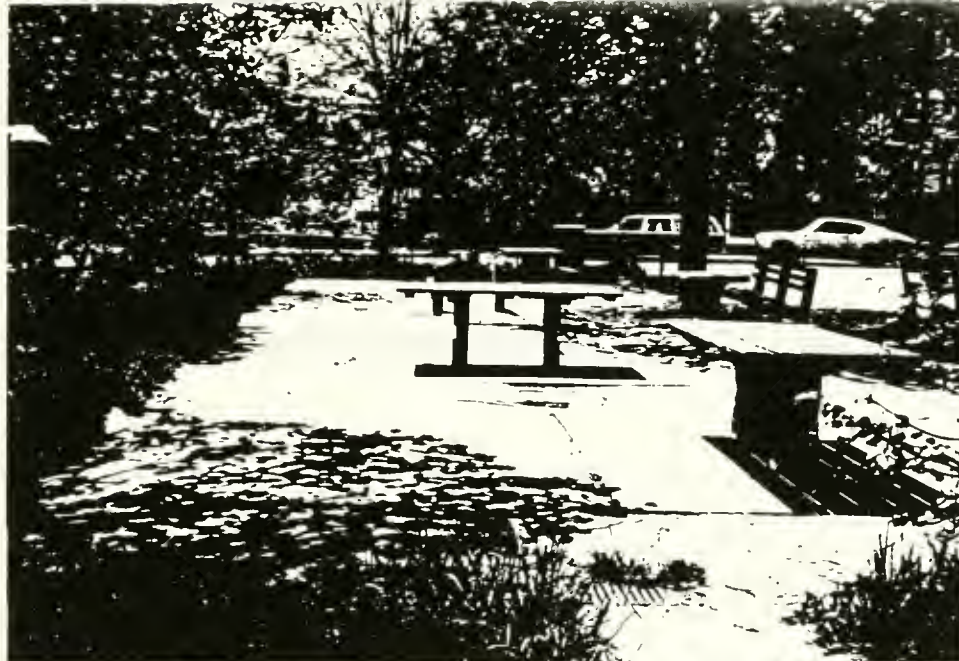
Site Photograph 4

Picnic area - broken tables and overgrown planting strip make space unattractive.

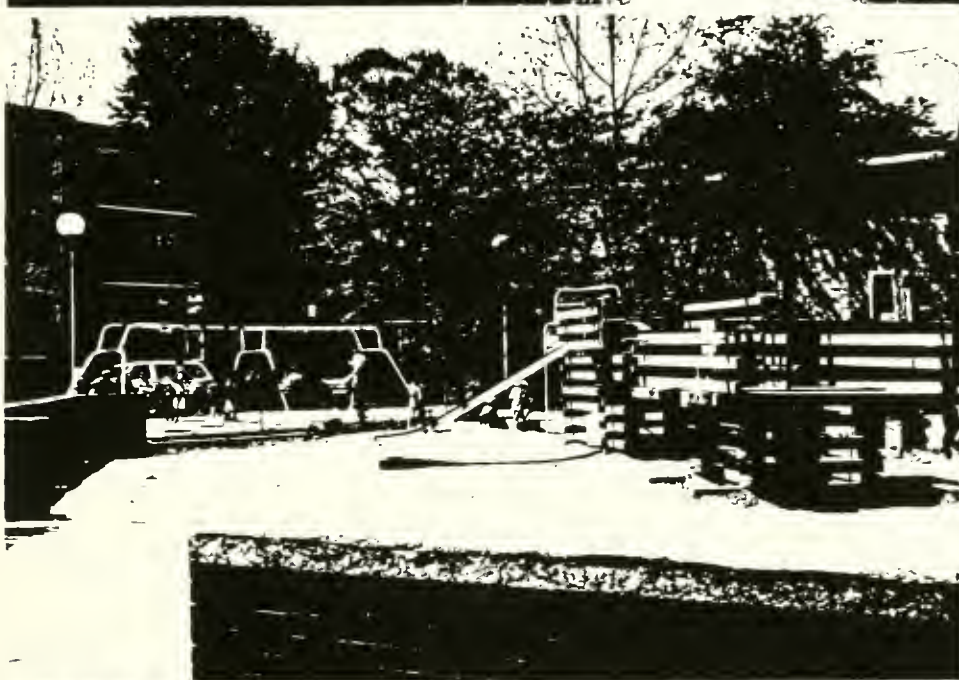
Site Photograph 5

Timber play structures and swings. Sand level too low.

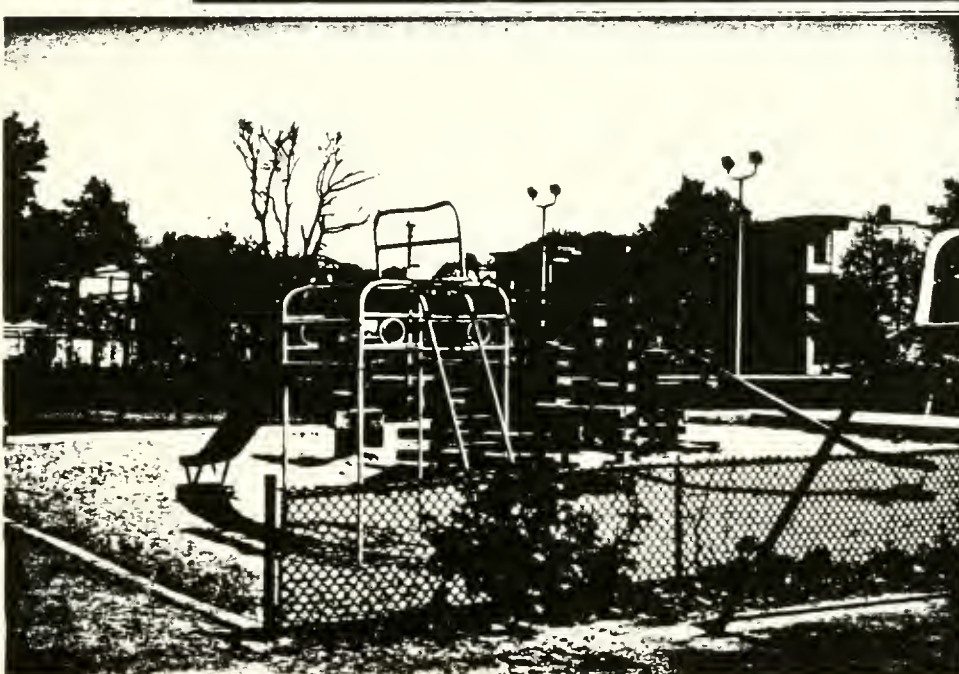
Site Photograph 6

Playground safety railing at top left of slide missing. Concrete footings exposed - both safety problems.

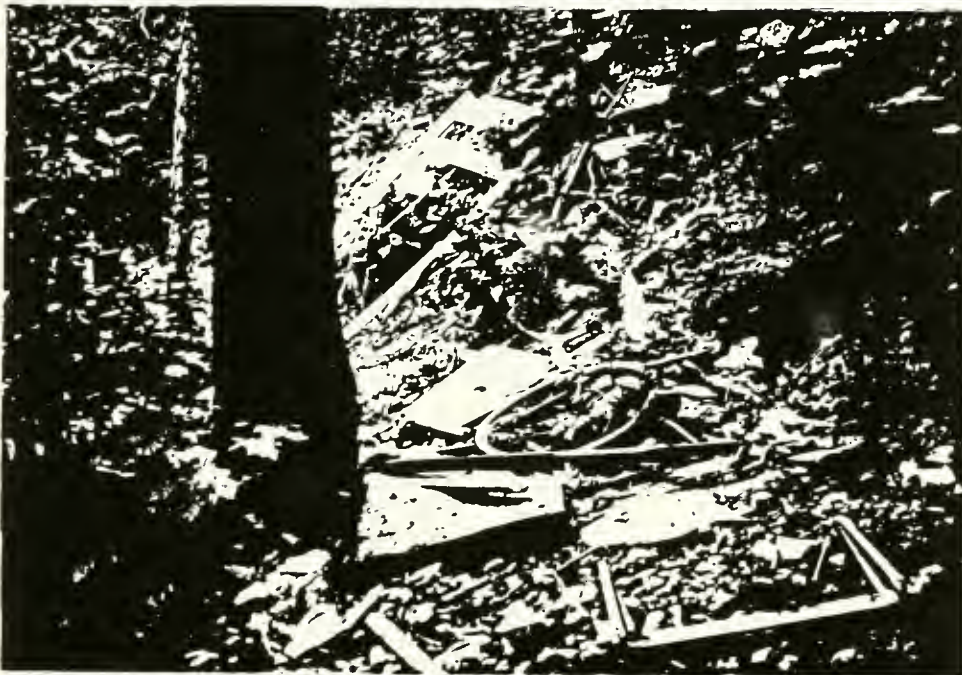
**Site Photograph 2**

Dumped material
covers entire site.

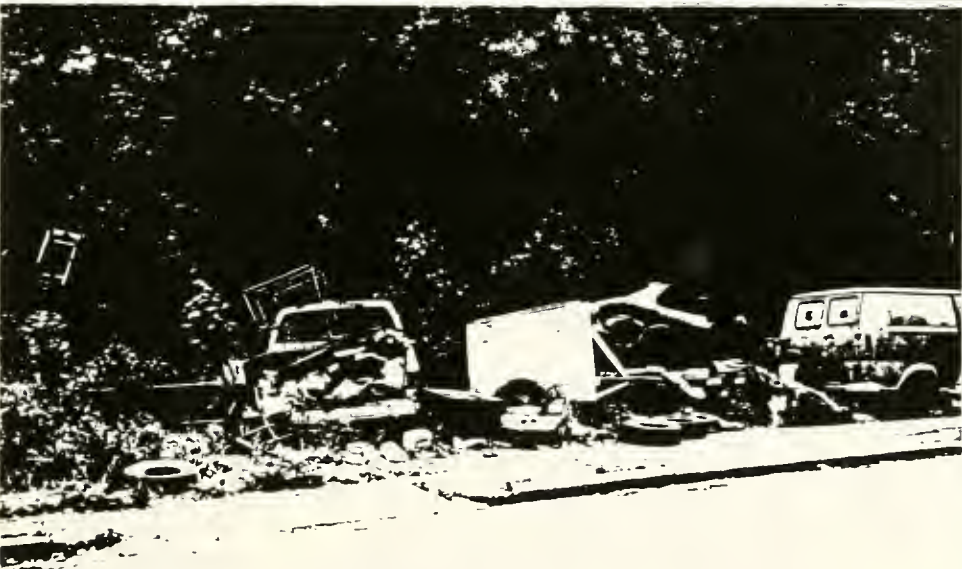
**Site Photograph 3**

Abandoned cars and
debris dumped on site.

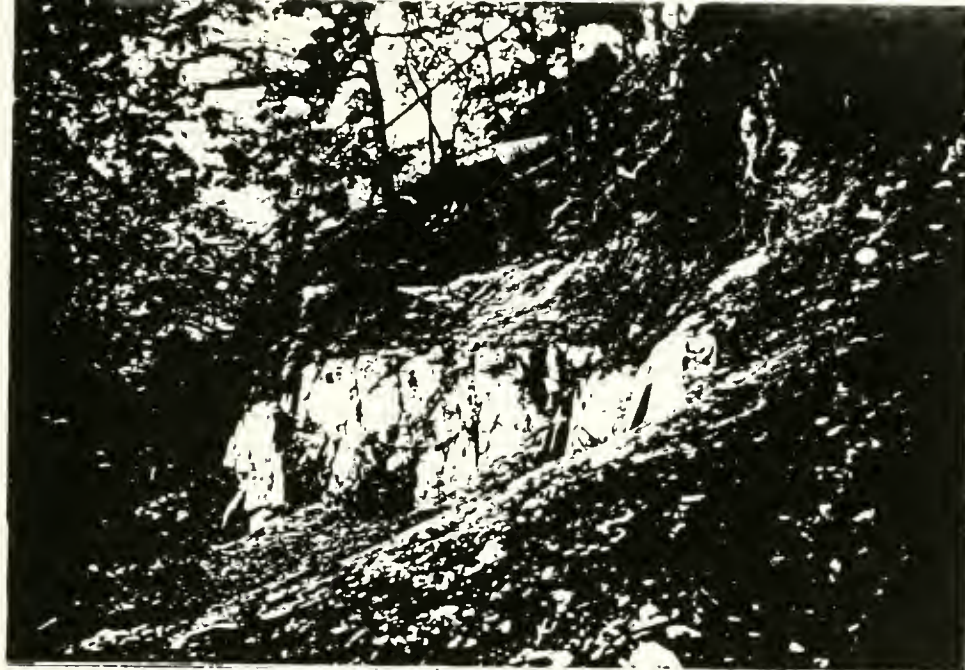
**Site Photograph 4**

Severe erosion,
presumably from play,
on slopes.

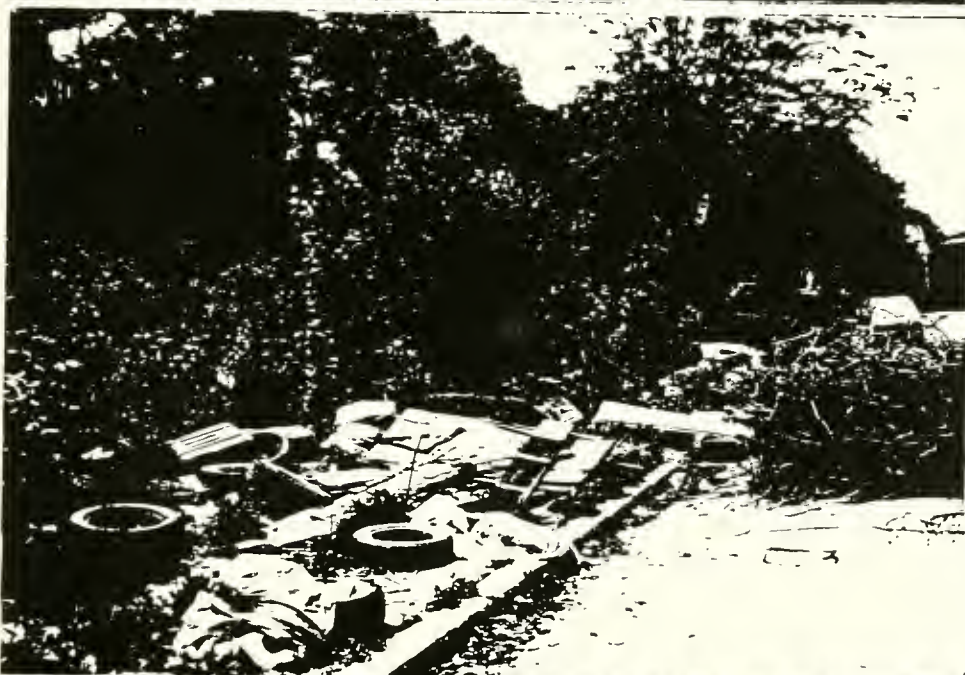
**Site Photograph 5**

Adjacent vacant site
used for dumping.
